AAL1GATOR-32 REVISION A DEVICE ERRATA

PM73122

REVISION A DEVICE ERRATA

ISSUE 4: MAY 2001

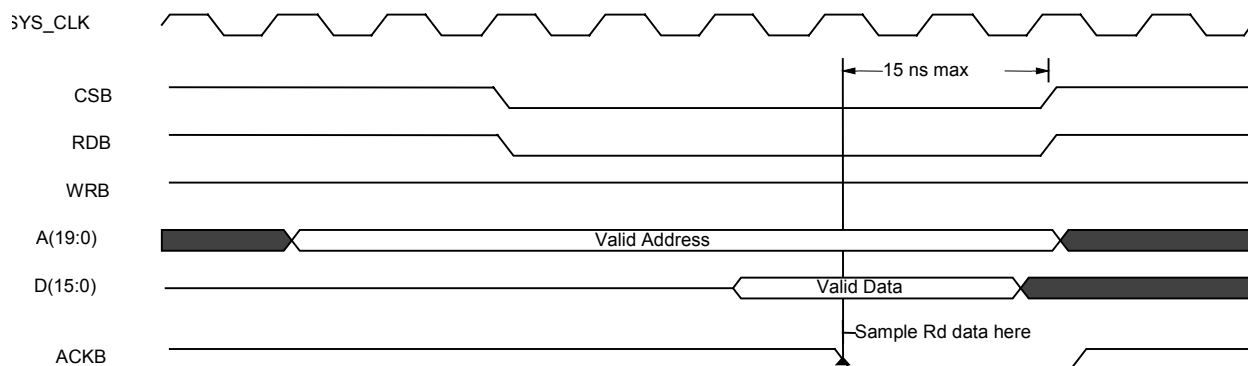
2.8.2.1 Asynchronous Solution

For read cycles of certain SBI Insert/Extract Bus Interrupt registers, if the RDB and CSB signals are held active for more than 50 ns after the falling edge of ACKB the data read may be corrupt; however, the fact that an interrupt occurred is never missed. The corrupt data that is read results in a possibly incorrect association of the interrupt to the actual link that caused the interrupt.

The AAL1gator-32 provides an ACKB signal to indicate when data is ready on chip reads. If the falling edge of ACKB is used to latch the data, and the CSB signal is deactivated within 15 ns of the falling edge of ACKB, reliable reads will occur.
