**PM7367**

**FREEDM-32P32**

**REVISION A DEVICE ERRATA**

**ISSUE 2: NOVEMBER 2001**

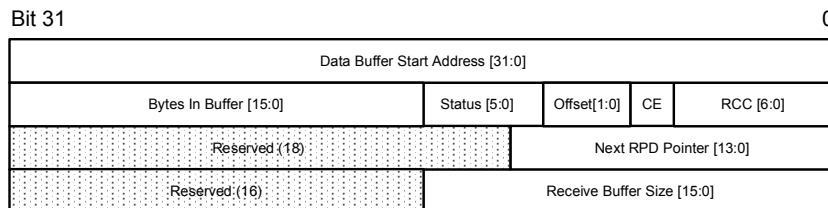
#### 2.1.1.1 Figure 2.1: Receive Packet Descriptor.

When ALL of the following conditions are met:

1. The offset[1:0] field of a Receive Packet Descriptor (RPD) is non-zero.
2. The STRIP bit of register "**0x204 RHDL Indirect Channel Data Register #1**" is logic one.
3. The incoming packet payload is smaller than the FCS field (2 bytes for CRC-CCITT or 4 bytes for CRC-32).

The value in the "Bytes in Buffer [15:0]" field of the RPD can be underflowed. That is, this field will contain a negative value. If this field is interpreted as an unsigned integer, the content of the buffer can be erroneously interpreted as a very large number.

If the "Bytes in Buffer" field is interpreted as a very large number, the driver software may attempt to read data from outside of the allocated buffer space.

1. If the Offset[1:0] bits of RPD are set to zero, this problem will not occur.
2. If the STRIP field of "**0x204 RHDL Indirect Channel Data Register #1**" is set to zero, this problem will not occur.
3. If the buffer size is not larger than 32K Bytes, the most significant bit of the "Byte in Buffer" field can be used as a sign bit. The device software should discard RPDs that contain a negative "Bytes in Buffer" value.

For every RPD, the driver software can compare the "Bytes in Buffer[15:0]" field to ensure that it is smaller than or equal to "Receive Buffer Size[15:0]".

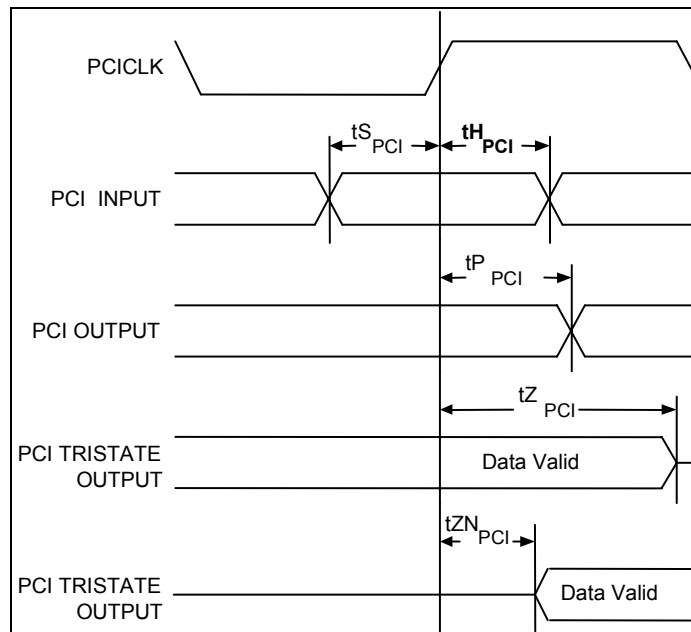
#### 2.3.1.1 Figure 2.2: PCI Interface Timing

PCI Input and Bi-directional signals require a minimum hold time ( $t_{H_{PCI}}$ ) of 1 ns with respect to PCICLK.

If the clock skew is not kept within the above limit, FREEDM-32P32 may operate incorrectly.

The PCI 2.1 specification requires PCI outputs to have a minimum 2 ns propagation delay. The clock skew between FREEDM-32P32 and other PCI devices in a system must therefore be kept below 1 ns to ensure correct operation.
