PM7375

Revision F Device Errata

Issue 4: December, 1997

This document is the Device Errata Sheet for the Revision F of the PM7375 LASAR-155™. This document is **not** the errata sheet for the LASAR-155 Long form Datasheet (PMC-931127).

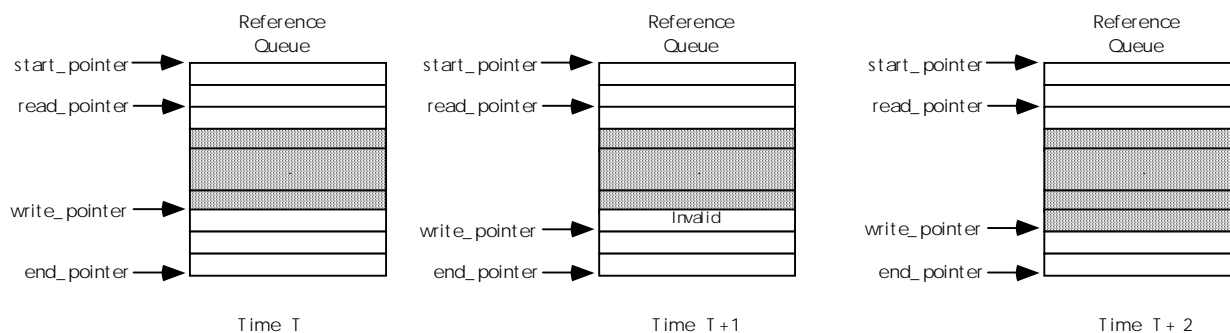
Figure 2.1: Queue Race Condition Example.

The race condition is that the write_pointer may be incremented before the element is fully written into the queue. When this occurs, the last queue element is invalid until the write operation is fully completed. This is illustrated in the example below:

- At "Time T", the LASAR-155 is ready to insert a new element into the Reference Queue.
- At "Time T+1", the write_pointer is increment before the new element is written into the queue. As a result, the position referenced by the write_pointer contains invalid data.
- At "Time T+2", the new element is added. Now the position referenced by the write_pointer contains valid data.

There is a possibility that the queue element may contain invalid data.

To ensure that only valid queue elements are read, the device driver first marks all queue elements as "unused". This is done when initializing the queues. When there is a notification that one or more elements are inserted into the queue, the device driver checks whether the queue element is "unused". If it is marked as "unused", the device driver will read the same position again until the new element is added. This is illustrated in the following example:

It is recommended that the "unused" be defined as "FFFFF".

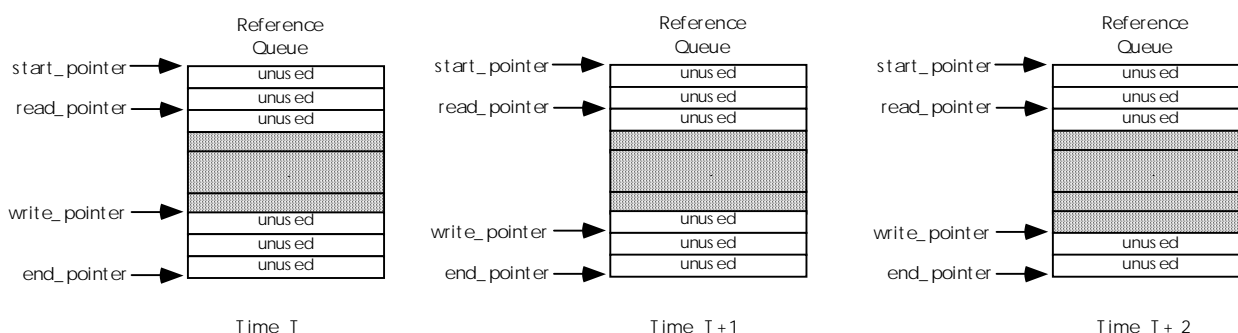
Figure 2.2: Work Around to Queue Race Condition.

- At "Time T", the LASAR-155 is ready to insert a new element into the Reference Queue. All the unused elements are marked "unused".
- At "Time T+1", the write_pointer is incremented before the new element is written into the queue. As a result, the position referenced by the write_pointer still contains the "unused" tag.
- At "Time T+2", the new element is added. Now the position referenced by the write_pointer contains valid data.

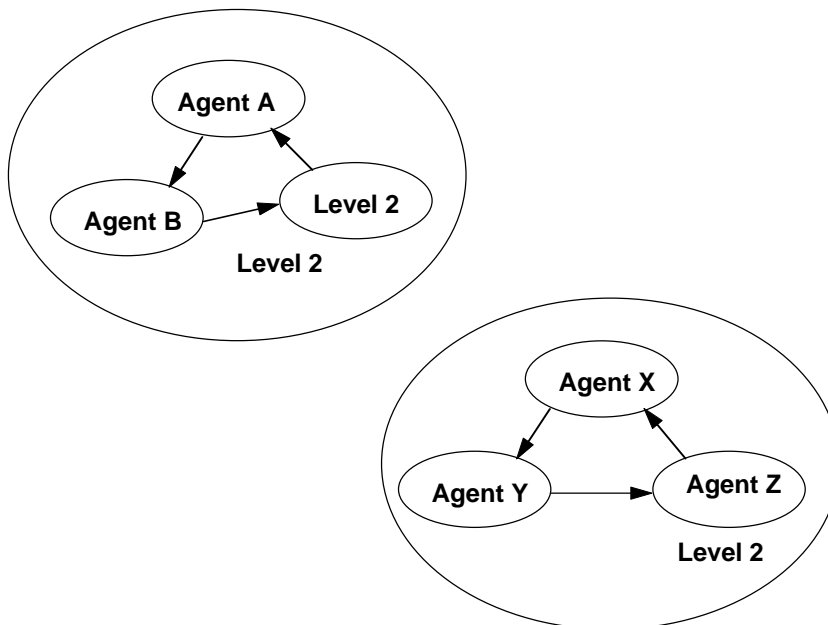
Figure 2.4 Typical PCI Bus Arbitration using a "Fairness Algorithm"

Second level agents have equal access to the bus with respect to other second level agents. However, second level agents, as a group, have equal access to the bus as level one agents as shown in the following example:

Normal operation should not be affected with the appropriate use of a Fairness algorithm for bus arbitration.
