MPC8260 PowerQUICC II™ Family Device Errata

This document describes all known silicon errata for the MPC8260 PowerQUICC II™ family of integrated communications processors. Refer to [Table 3](#) for a list of devices.

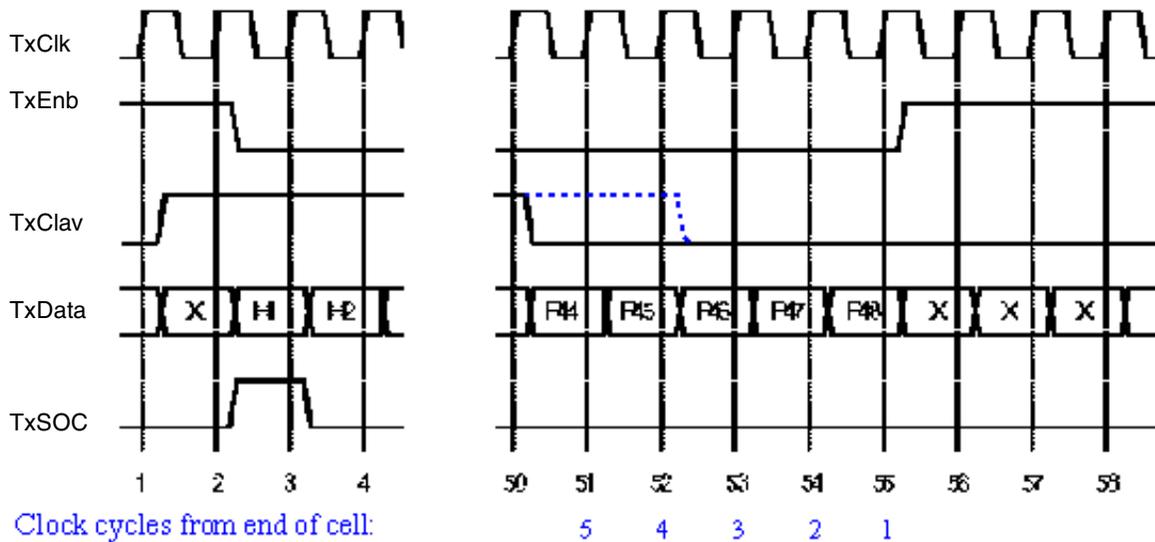
Figure 1. Transmit Timing for Cell-Level Handshake

CPM101: FCC RxClav timing violation (slave).

FCC ATM Receive UTOPIA slave mode. When the RxFIFO is full, RxClav is negated 2 cycles before the end of the cell transfer instead of 4. A master that polls RxClav or pauses 3 or 4 cycles before the end of the cell transfer may sample a false RxClav and an overrun condition may occur. The dashed line in the timing diagram below depicts the actual RxClav negation (two cycles before the end of the cell transfer instead of four cycles). The signals in the timing diagram are with respect to the master hence Tx interface is shown.

1. Master should not poll RxClav or pause cell transfer at 4 cycles before the end of cell transfer. Master should poll 2 cycles before the end of the current cell or later. This can be achieved by introducing a cell-to-cell polling (and transfer) delay, which is equal or larger then one cell transfer time. If this can be achieved, the impact on performance is minimal.
2. Configuring ATM only on FCC1 and setting FPSMR[TPRI] ensures highest priority to FCC1 Rx. In addition, for CPM utilization lower then 80% (as reported by the CPM performance tool based on UTOPIA maximal bus rate) the CPM performance is enough to guarantee that the RxFIFO does not fill up.

- Multi-PHY with single Clav polling—Master should ensure that the address corresponding to an MPC826xA slave is not placed on the address bus before 5 cycles before the end of a cell transfer to that slave.
