**Errata Document for CY7C637xx / enCoRe™ USB Combination Low-speed USB & PS/2 Peripheral Controller**

**1. Faulty GPIO Interrupt**

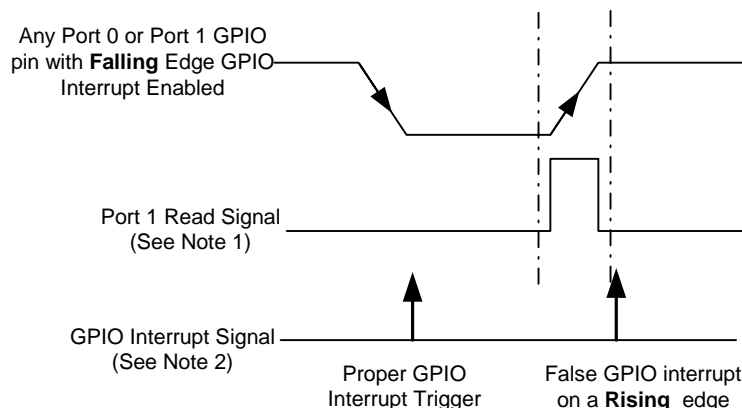
When a falling edge interrupt is enabled for a GPIO pin, reading the GPIO Port 1 coincident to a rising edge of that GPIO signal may generate a false GPIO interrupt.

Workarounds will need to be tailored to individual applications based on the flexibility of changing the GPIO usage, the timing of the GPIO interrupt sources and firmware interrupt latencies.
