ERRATA PMC-981005 PMC-Sierra, Inc.

PM5349 S/UNI-QUAD

S/UNI-QUAD DATASHEET ERRATA

ISSUE 3: JUNE 1999

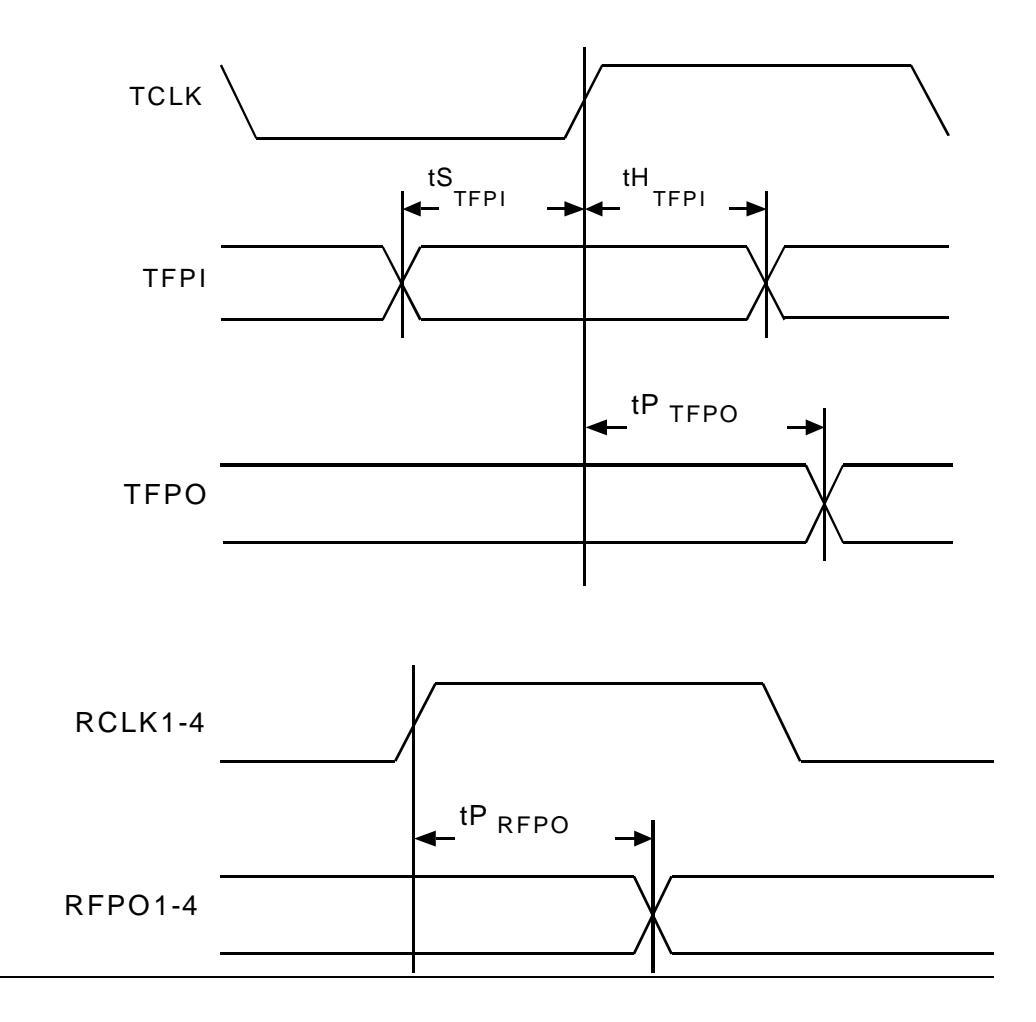
Figure 1: Transmit and Receive Frame Pulses

3.13 Pg. 263 Revised TFPI Setup and Hold times

Symbol	Description	Min	Max	Units
tS _{TFPI}	TFPI Set-up Time to TCLK High	10 - 15		ns
tH _{TFPI}	TFPI Hold Time to TCLK High	10 0		ns
tP _{TFPO}	TCLK High to TFPO Valid	0	10	ns
tP _{RFPO}	RCLK1-4 High to RFPO1-4 Valid	0	10	ns
