Errata and Added Information to
**MC68360 Quad Integrated Communication
Controller User's Manual Rev 1**

January 8, 1998

This document describes the latest information and changes to the first revision of the MC68360 user's manual.

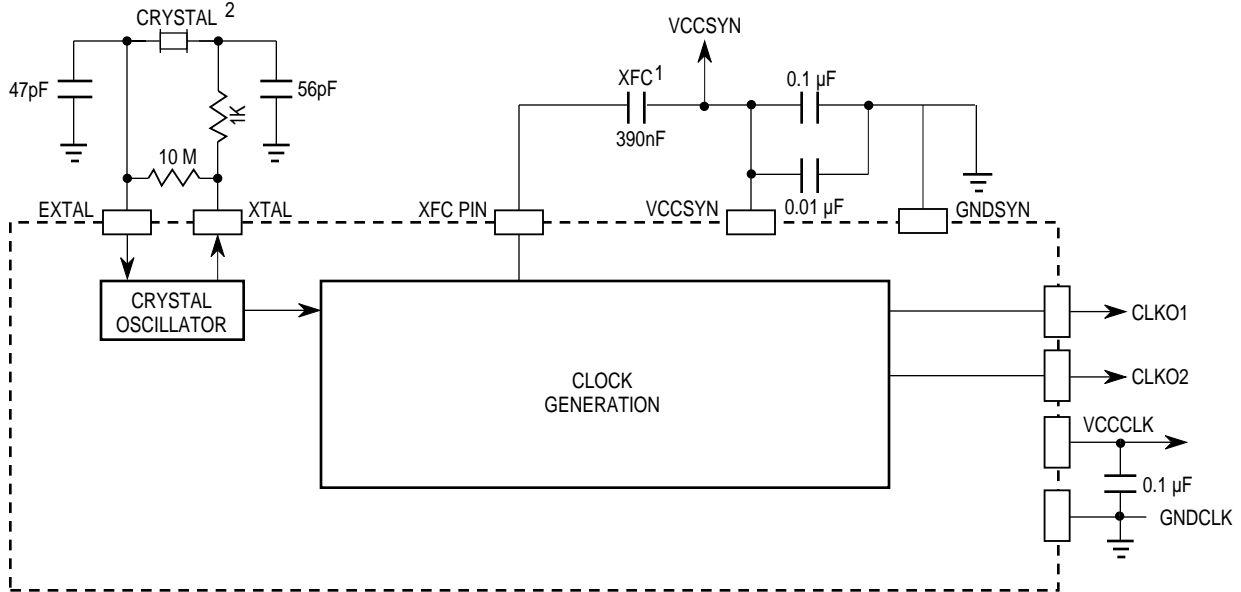
Figure 6-6A External Components for 4.192MHz

Also on page 6-14 the following figure should be added.
