PM5356

S/UNI-622-MAX

**SATURN USER NETWORK INTERFACE
(622-MAX)**

ERRATA

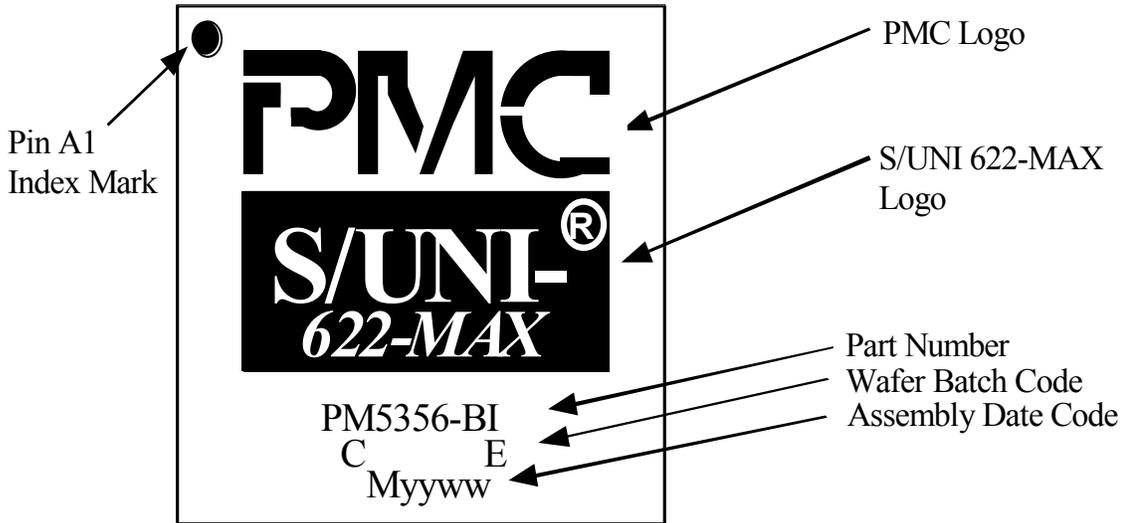
Figure 1: PM5356 S/UNI-622-MAX Branding Format

The information contains in this document applies to the PM5356 S/UNI-622-MAX revision E device only. The device revision code is marked at the end of the Wafer Batch Code on the face of the device (as shown in Figure 1). PM5356 S/UNI-622-MAX revision E is packaged in a 304 pin Super BGA package.

TOP VIEW
SCALE : 2:1
(APPROX.)
